NO. FAS-006

Fuji Heavy Industries, LTD.

DATE 17 October, 1969.

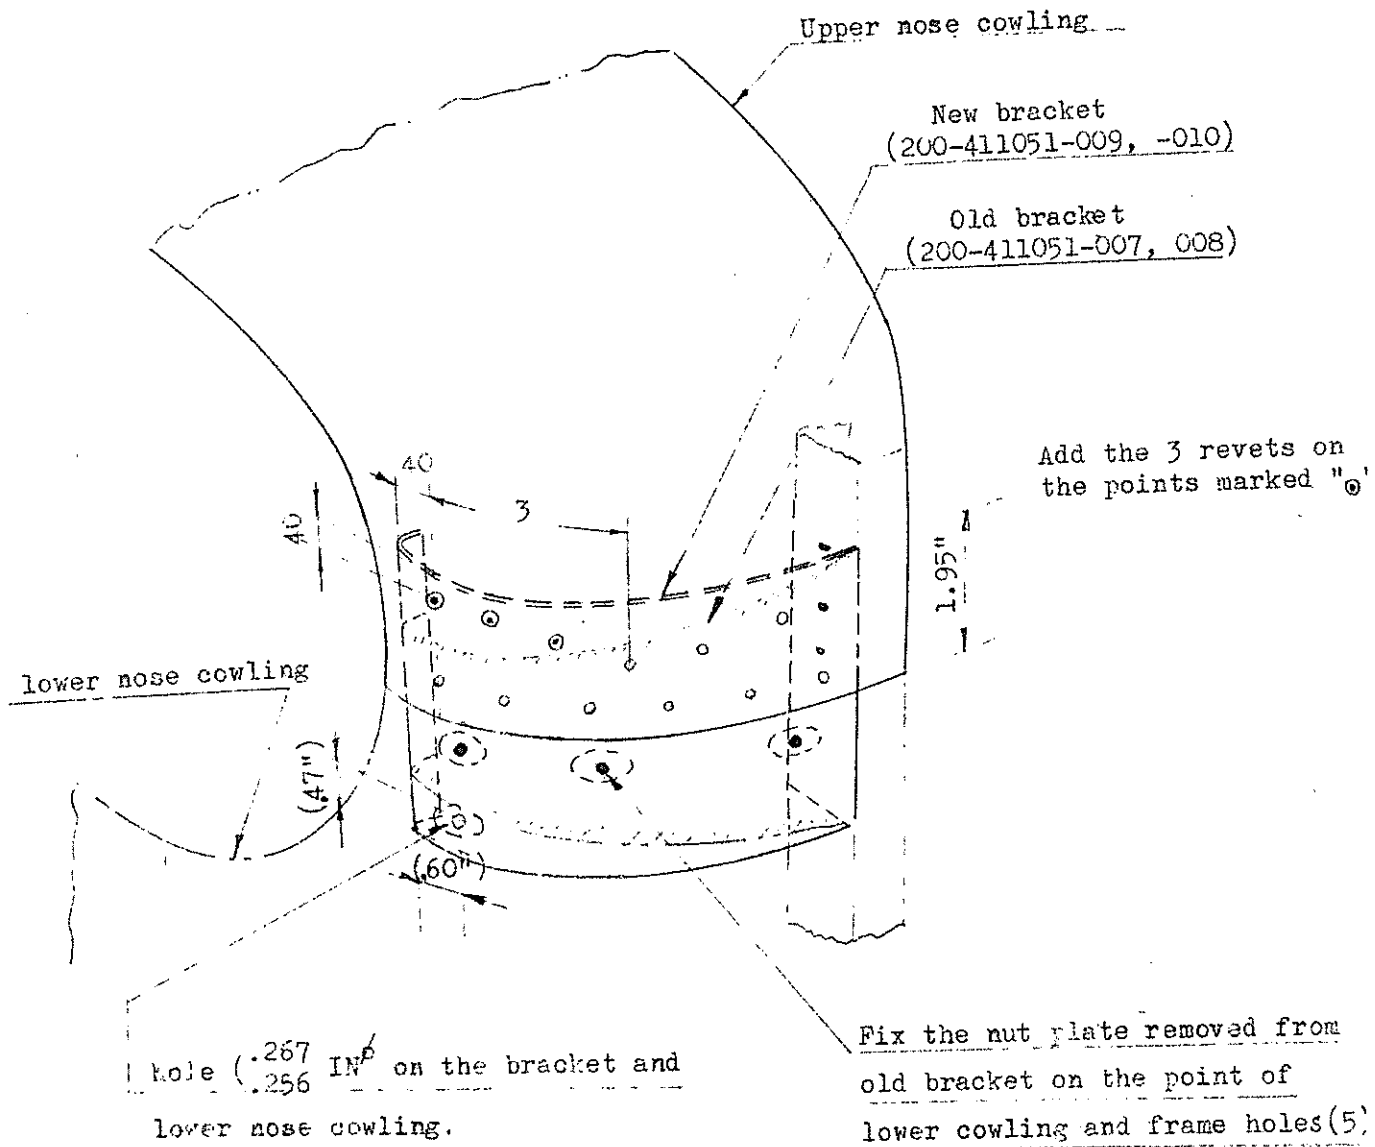
1. SUBJECT : Improvement of nose cowling bracket.
2. AIRCRAFT AFFECTED : FA-200, Serial No. 12 through 75 airplanes.
3. PRIORITY : Desirable.
4. REASON : To avoid the crack on the bracket fixing the upper and lower nose cowling.
5. DESCRIPTION : Replace the bracket to the new one.
(P/N 200-411051-009, -010)
6. ACCOMPLISHMENT : On any time.
7. APPROVAL : Not applicable.
8. PARTS REQUIRED:

- (1) Remove the upper cowling.
- (2) Replace the bracket revetted on the upper nose cowling fixing the upper and lower nose cowling, to new one. (200-411051-009, -010)
- (3) Install the upper nose cowling. On this time, make a hole $\begin{matrix} .267 \\ .525 \end{matrix}$ IN^Ø on the lower cowling on the same point of the nut plates on the bracket and fasten the screw, AN525-416R8.
