S E R V I C E B U L L E T I N

NO. FAS-035

1. SUBJECT : ONE TIME INSPECTION FOR FRONT LANDING GEAR.

2. AIRCRAFT AFFECTED : FA-200 Serial Nos 1 thru 101.

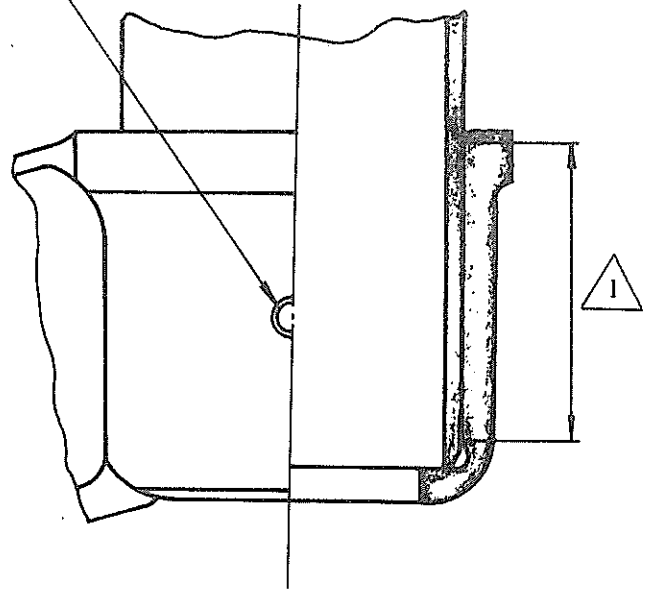
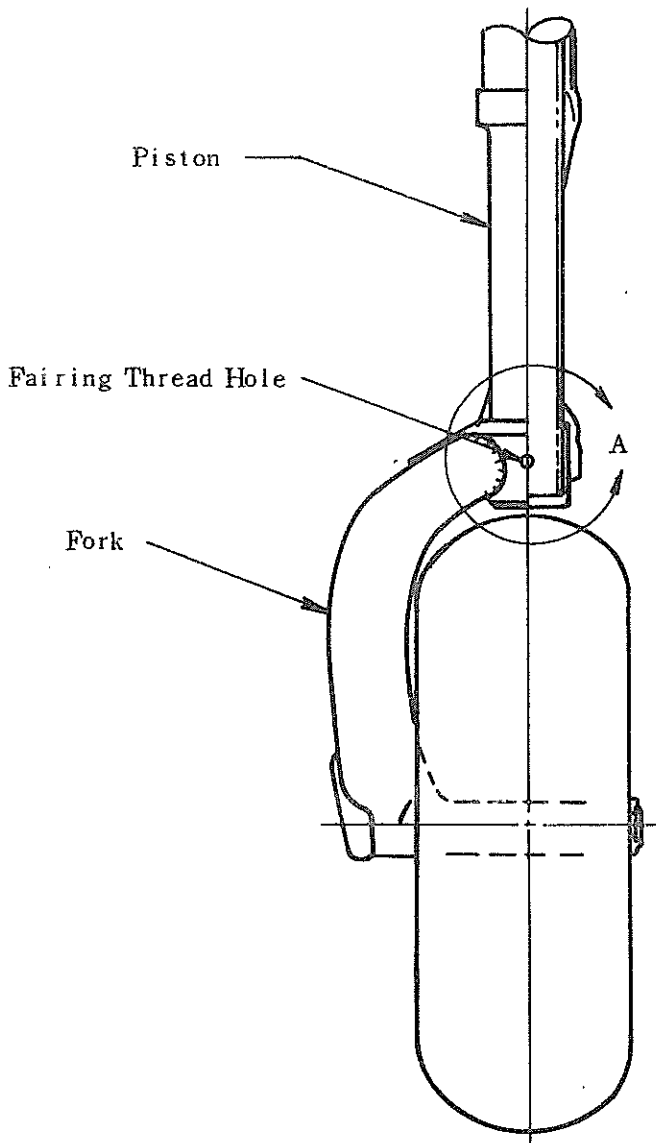
Figure 1. Front Landing Gear Assy
(View Looking Aft)

4. REASON : In order to inspect front landing gear, since an instance was reported where the piston of the subject landing gear slipped from the fork during ground handling of an FA-200 aircraft.

- 1) By driving AN3 bolt, inspect to see that the fairing fitting thread hole (#10-32) through piston and fork is in line.

- 2) Check to be sure that piston is completely positioned at the bottom of fork, with no clearance between piston end and fork flange, as shown in Figure 1, Detail A. This can be checked with the aid of a mirror inserted between fork and tire.
- 3) Any piston slippage, if revealed by the above inspection item 1), or 2), shall be immediately reported to Fuji Heavy Industries Ltd.

Fairing Thread Hole
(To inspect by driving AN3 bolt)

Detail A

Note: If the above bolt is not driven smoothly, visually inspect to determine the causes of binding such as mismatched holes, burrs due to damaged threads, clogged dirt, etc.

In the case of binding caused by burrs or dirt, remove and clean burrs on dirt, and recheck hole alignment.
