SERVICE BULLETIN

NO. FAS-087

July 24, 1970

FUJI HEAVY INDUSTRIES LTD

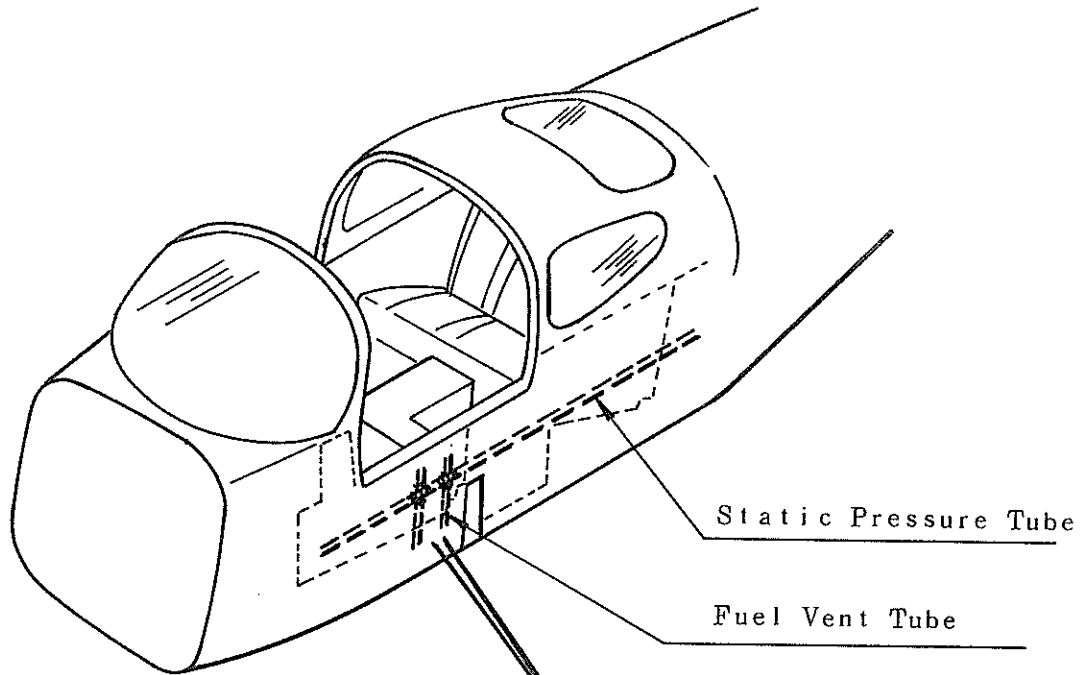
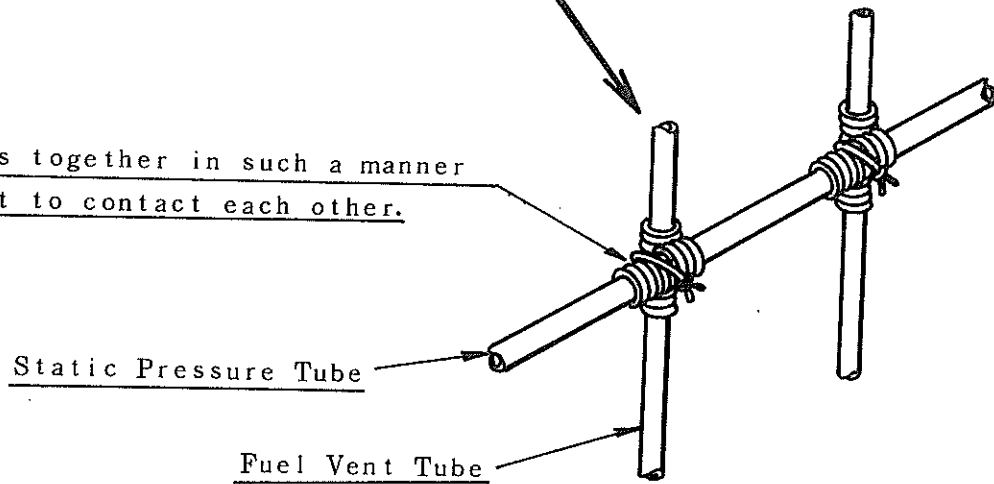
1. SUBJECT CONTACT PREVENTION, STATIC PRESSURE TUBE AND FUEL VENT TUBE, LEFT SIDE CABIN.
2. AIRCRAFT AFFECTED : FA-200 Serial Nos. 12 thru 100.
3. PRIORITY : Desirable.
4. REASON :  
When left fwd cabin upholstery panel is pushed outboard by the pilot elbow, the subject two tubes, at the place where they intersect, are liable to contact each other, causing dent in either tube. It is, therefore necessary to tie the tubes together with lace in order to prevent such damage as dent.
5. DESCRIPTION :  
Static pressure tube and fuel vent tube to be firmly tied together in accordance with Item 18, Detailed Instruction.
6. ACCOMPLISHMENT : At any time.
7. APPROVAL : Not applicable.
8. PART REQUIRED : Lace, 500mm long (~~Mitsuboshi Co~~)

9. SPECIAL TOOLS : None required.
10. WEIGHT AND BALANCE : Weight and balance change resulting from  
this directive is negligible.
11. REFERENCE : None
12. MANHOURS REQUIRED : 2 Manhours required.
13. DETAILED INSTRUCTION :
- 1) Remove left fwd seat.
  - 2) Remove left fwd panel.
  - 3) Check to be sure that there is no dent on  
vent tube and static pressure tube.
  - 4) Using lace, tie static pressure tube and fuel vent tube  
as shown Page 3
  - 5) Install left fwd panel and seat.

Tie tubes together in such a manner  
so as not to contact each other.
