SERVICE BULLETIN

FUJI HEAVY INDUSTRIES LTD.

NO : FAS-052

DATE : February 15, 1971

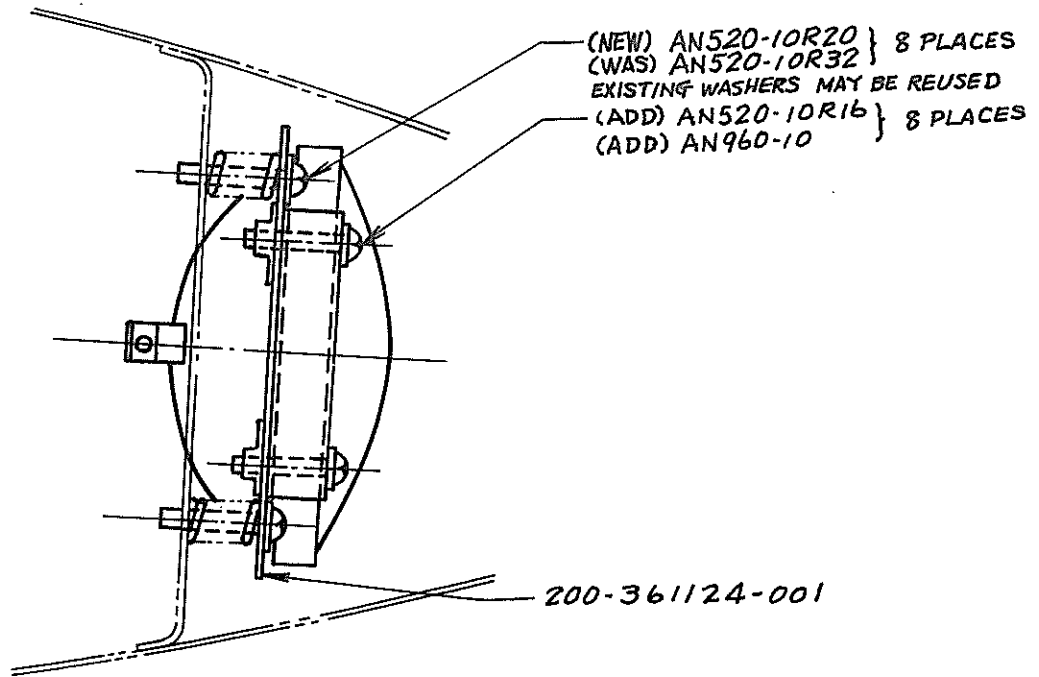
FIG. 1

1. SUBJECT : Improvement in Landing and Taxi Lights Installation.
2. AIRCRAFT AFFECTED : FA-200 Series serial Nos. 1 thru 101.
3. PRIORITY : Desirable.
4. REASON : In order to improve security and also to prevent possible crack of the subject lights, plates will be patched for channels.
5. DESCRIPTION : Plates to be patched and channels reworked.
6. ACCOMPLISHMENT : Optional.
7. APPROVAL : Not applicable.
8. PARTS REQUIRED : The following parts are required to perform the modification:

- (2) Back off screws and remove four channels attaching the two lights. Then pull forward the lights.
 - (3) Separate harness from the lights.
 - (4) Install two plates, 200-361124-001, in positions as illustrated in figure 1.

- (7) Connect harness to the landing light and to the taxi light. Install the reworked channels to the plates with eight screws, AN520-10R16, and eight washers, AN960-10. See figure 1.
