SERVICE BULLETIN

FUJI HEAVY INDUSTRIES LTD.

NO. 200-002

1. SUBJECT : Inspection and modification of rudder pedal operation.
2. AIRCRAFT AFFECTED : All FA-200 series aircraft S/N 12 thru. 297.
3. PRIORITY : Mandatory
4. REASON : To prevent overtravel of rudder pedal and to ensure proper operation of rudder control system, this bulletin specifies inspection and modification if required.
5. DESCRIPTION : (1) Inspection - Rudder Pedal Stop

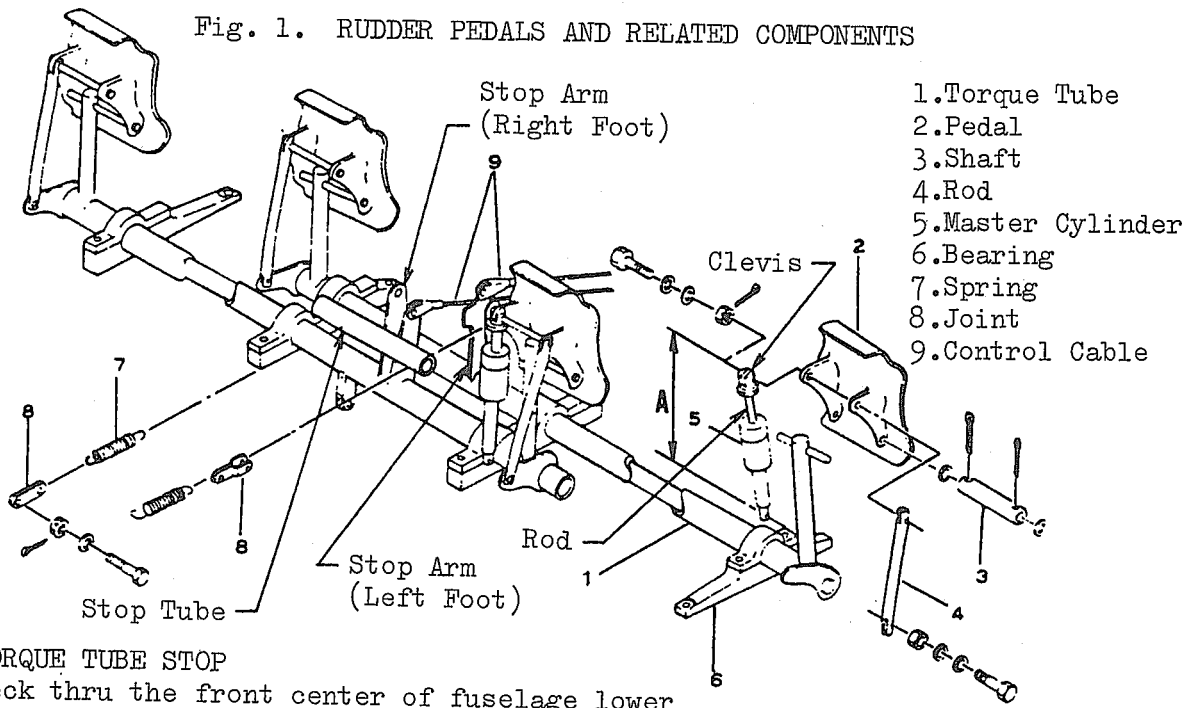
Fig. 1. RUDDER PEDALS AND RELATED COMPONENTS

Check left (foot) and right (foot) rudder pedal stops for clearance within specified hours described in "6, ACCOMPLISHMENT" after receipt of this bulletin. Under properly adjusted condition, stop clearance with full rudder travel should be 5mm(0.2in) or less for left pedal and 2.5mm(0.1in) or less for right pedal. Corrective action per para 12 of this bulletin is required if these limits are exceeded.
- (2) Inspection - Brake Master Cylinder Length (Affected Brake Master Cylinder: P/N 0541138-20)

Brake master cylinder is to be adjusted to length as short as possible within range not interfering with rudder pedal tabs. Dimension between both centers of bolt holes should be 204.5 mm (8.05 in) or less. It is required to shorten rod end if measurement is more than 204.5 mm. Details are described in section 12 of this bulletin. These reworks should be accomplished within specified hours described in section 6 of this bulletin.
- (3) Inspection - Brake Link Over-center Force
Note: This inspection is not required after compliance with Technical Bulletin 200-022.

Check thru the front center of fuselage lower access panel

Full length of "A" should be 204.5mm(8.05 in) or less.

- (1) Remove the front center of fuselage lower access panel.
- (2) Check rudder system for proper adjustment. This check should be performed with nose gear free from ground or rudder pedal torque tube free from steering rods, whichever convenience. (Refer to Service Manual, para 8-4-3.)

- (3) Operate from the condition (2) and keep rudder pedal until control surface contacts its stop. Then check rudder pedal stop arm for proper clearance. If clearance is 5 mm (0.2 in) or less for left pedal and 2.5 mm (0.1 in) or less for right pedal, no further action is required. Reinstall removed parts.

- (4) Check again rudder pedal and rudder for neutral position if measured stop clearance is more than 5 mm (0.2 in) for left and 2.5 mm (0.1 in) for right. Then adjust as required.

- (2) Check clevis for proper thread engagement.
- (3) Length between bolt hole centers at both ends should be 204.5 mm (8.05 in) or less in the fully extended position.
If any interference is noted by this adjustment between rudder pedal and clevis rod end, trim the rod end to provide clearance.

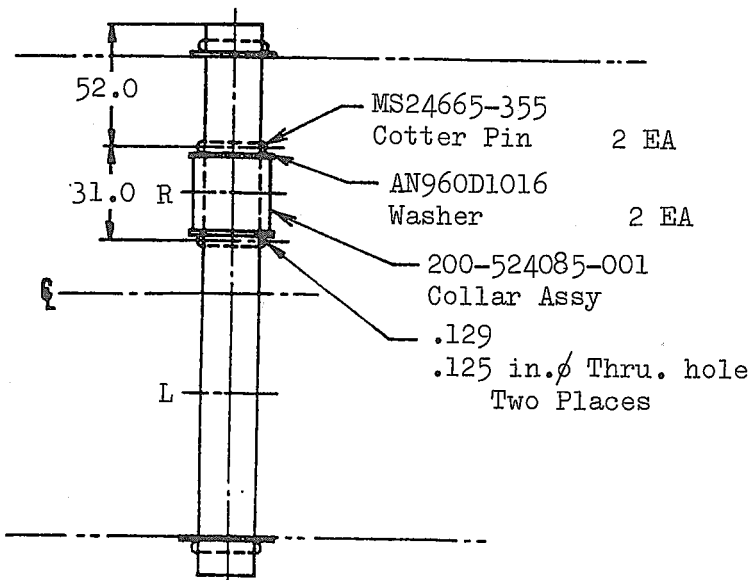
Fig. 2. STOP TUBE MODIFICATION

Left Fig. shows right foot pedal stop collar installation. Left pedal stop collar is installed on opposite side of center line.

- (5) Remove stop tube and install collar assy as shown in Fig. 2, if the measured stop clearance still exceeds 5 mm (0.2 in) for left and 2.5 mm (0.1 in) for right after step (4) is performed.
Removal of stop tube can be accomplished by removing either one of cotter pins.

Make thru hole ($\frac{.128}{.125}$ in) as shown in Fig. 2 and apply zinc chromate primer or equivalent corrosion preventive paint to the holes.

- (6) Install stop tube with properly matched collars. Tube and collar should be secured with cotter pin.
- (7) Recheck stop clearance and then reinstall removed parts.

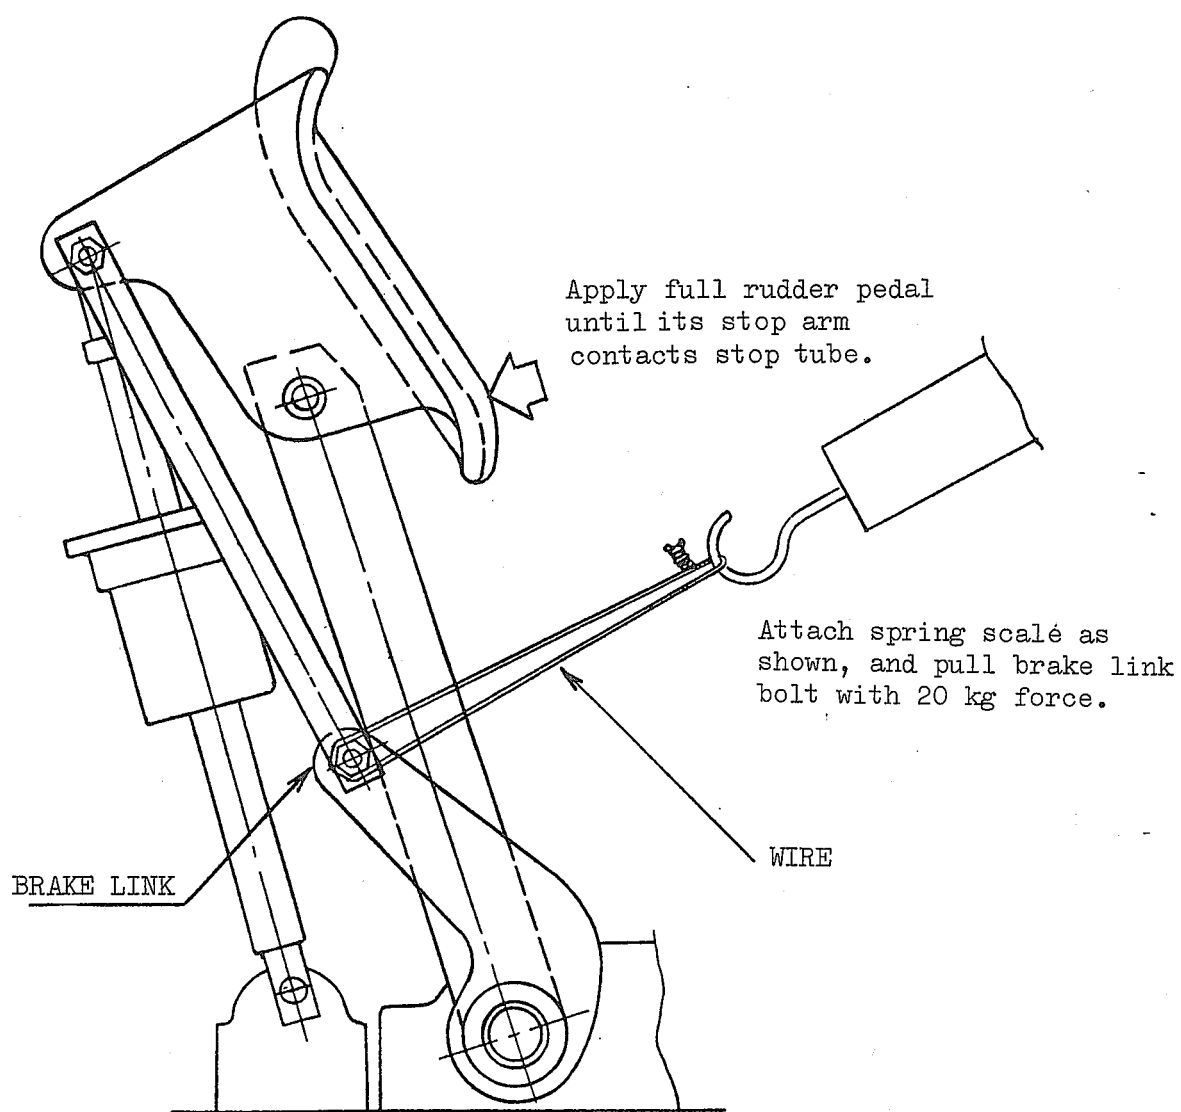
Fig. 3. OPERATIONAL CHECK - BRAKE LINK OVER-CENTER FORCE

With rudder pedal stop arm contacting stop tube, brake link bolt is pulled with 20 kg force. The brake link should not be over-

centered (go beyond dead center).
(See Fig. 3 and para 12 for detailed instructions.)

- (1) Install wire around brake link connecting bolt as shown in Fig. 3.
- (2) For each of left and right rudder pedals, apply full rudder pedal until its stop arm contacts stop tube. In this condition, pull brake link bolt with 20 kg force as shown in Fig. 3. The brake link should not be over-centered (go beyond dead center).
- (3) If the above check reveals over-centering, inspect link detailed parts for wear and other damages. Replace defective part(s) and repeat operational check per above step (2).
