SERVICE BULLETIN

FUJI HEAVY INDUSTRIES LTD.

NO. 200-004 DATE 57-10-8 (SUPERSEDES NO.)
REV. DATE (SUPERSEDES NO.)
REASON

1. SUBJECT : Engine Driven Fuel Pump Outlet Tee, Inspection and Replacement of
2. AIRCRAFT AFFECTED : All FA200-180 aircraft S/N 12 and sub (excluding-180AO)

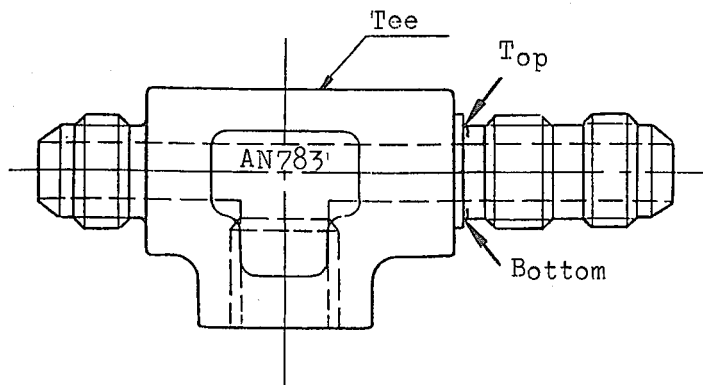
Figure 2. Inspection of Tee (AN783-6)

3. PRIORITY : Mandatory
4. REASON : There have been instances reported whereby crack has been found in the engine driven fuel pump outlet tee (AN783-6). In the interest of flight safety, we are directing inspection and replacement of the subject tee.

Inspect tee for crack or leakage around area indicated by arrows, paying particular attention to top and bottom.

5. DESCRIPTION : (1) Leak Check :
- With mixture lever in "Cut-Off" position, turn auxiliary fuel pump "ON", and check engine driven fuel pump outlet tee for fuel leakage at the position as shown in the attached figure 2. If fuel leakage is found, replace the tee (AN783-6) with new serviceable item.

- (2) Dye Penetrant Check :
- Remove engine driven fuel pump outlet tee, and, using a dye penetrant inspection method, ensure no cracks exist in the location as shown in the figure 2. If crack is found, replace the tee (AN783-6) with new serviceable item.

- (3) Replacement :
- Replace engine driven fuel pump outlet tee (AN783-6) with new serviceable item. Discard the removed tee.
6. ACCOMPLISHMENT : (1) Airplanes with less than total 3000 hours:
