# SERVICE BULLETIN

TEIJIN SEIKI CO., LTD.  
GIFU PLANT,

NO. TS-SB-72      DATE 1-10-84  
REV                      DATE  
                            REASON

Phase 1 : Inspection of FIF40000 Fuel Strainer, for prevention of fuel-blockade.

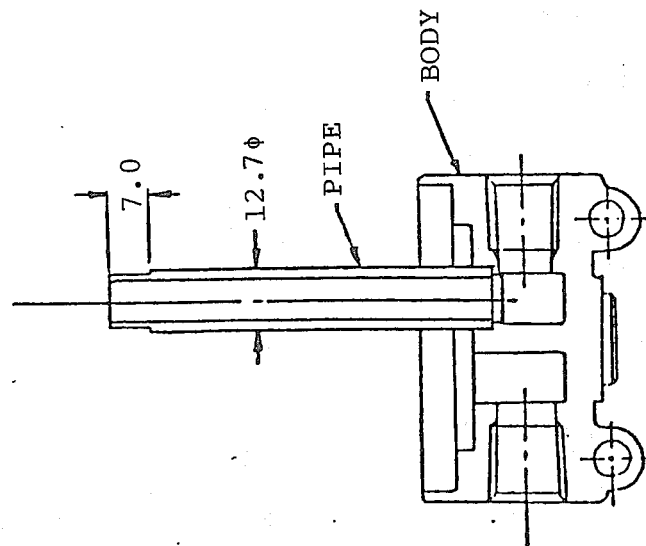
Strainer, repair work not required

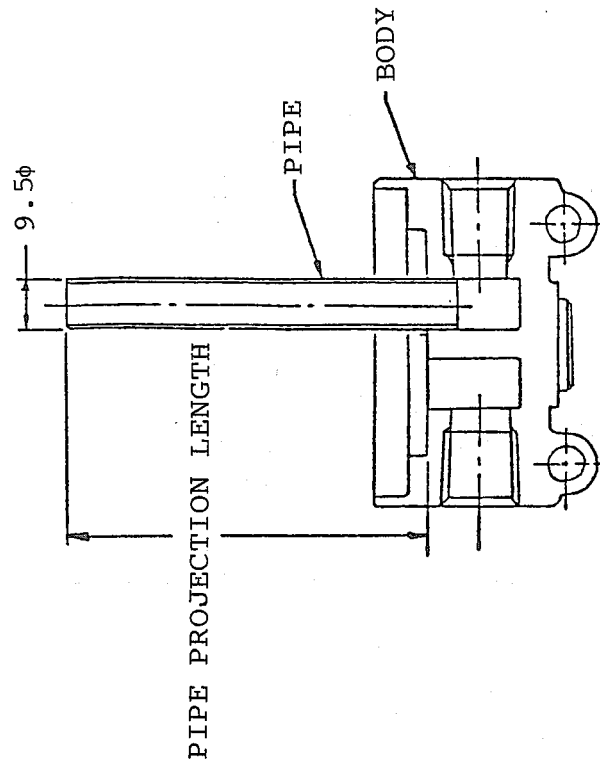
Fig.-1

Condition; loose pipe and/or pipe which projects less than 62mm from the surface of the body.

Strainer, repair work required

Phase 2 : The repair work is to replace the pipe with FIF40020 pipe.

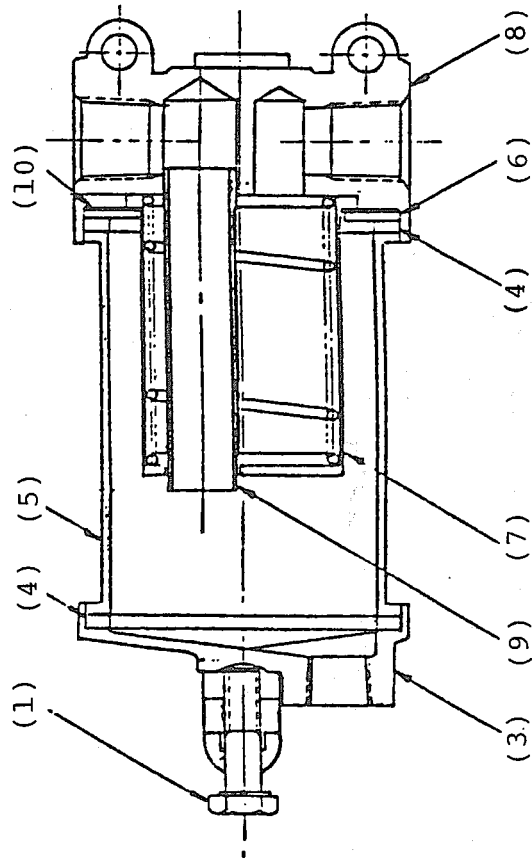
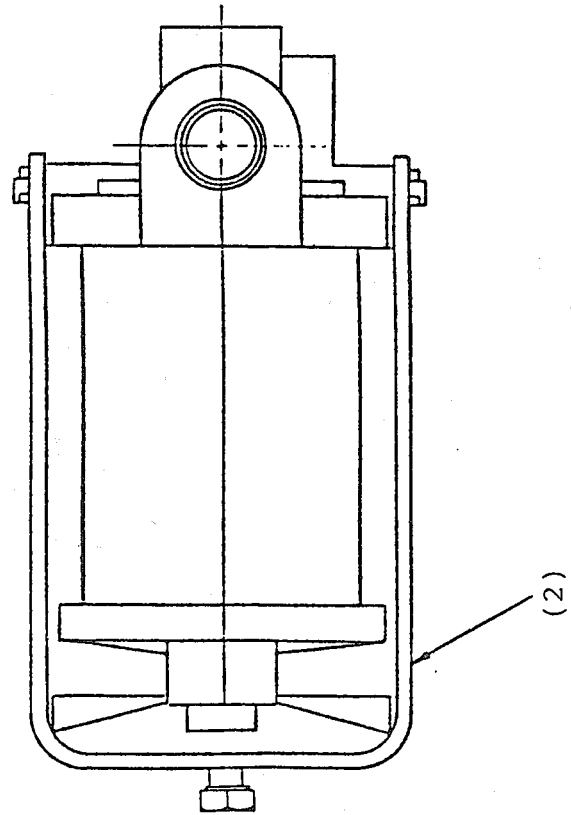
Fig.-2 STRAINER ASSEMBLY (before repair)

In connection with some particular model of FIF40000 Fuel Strainer, there is slight chance of its piece part; FIF40008 pipe becoming loose in the body, which might result in fuel-blockade.

- 1) Remove and discard lockwire from bolt (1).
- 2) Untighten bolt (1), tilt bracket (2) and remove cover (3), packings (4) (10), barrel (5), washer (6) and screen (7).
- 3) Pull out pipe (9) from body (8).
- 4) Check and clean the hole in the body (8) and insert the replacement pipe (P/N FIF40020) into the hole by pressing or by tapping it with a plastic hammer, until a shoulder on the pipe comes in contact with the surface of body (8).  
Clean the parts. (Reference : Fig.-3)
- 5) Clean and reassemble the parts that have been removed in paragraph 2). Tighten bolt (1) to the torque of 15-20 IN.LBS.
- 6) Apply lockwire on bolt (1).
