# SERVICE BULLETIN

FUJI HEAVY INDUSTRIES LTD.

NO. 200-015                      DATE 2006. 2. 28.

1. SUBJECT : Wing Main Spar; Corrosion Inspection and Repair of
2. AIRCRAFT AFFECTED : All FA-200 series aircraft
3. PRIORITY : Mandatory
4. REASON : To inspect and, if necessary, repair the flanges of the main wing spars, since field reports indicate a possibility of corrosion occurrence on these flanges.

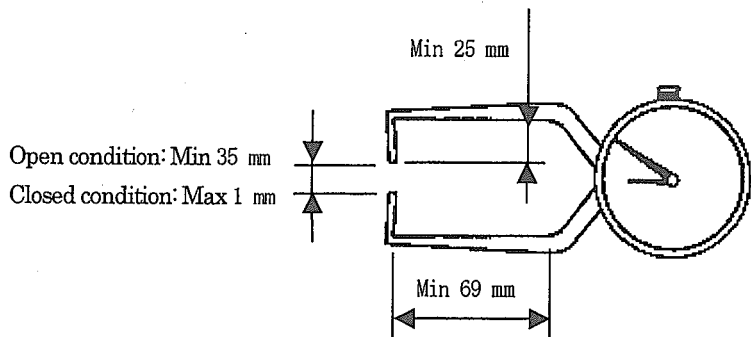
Figure 1 Measuring Gage (Example)

The measuring portion of the gage must conform to the requirements as shown, to prevent interference with main spar flanges

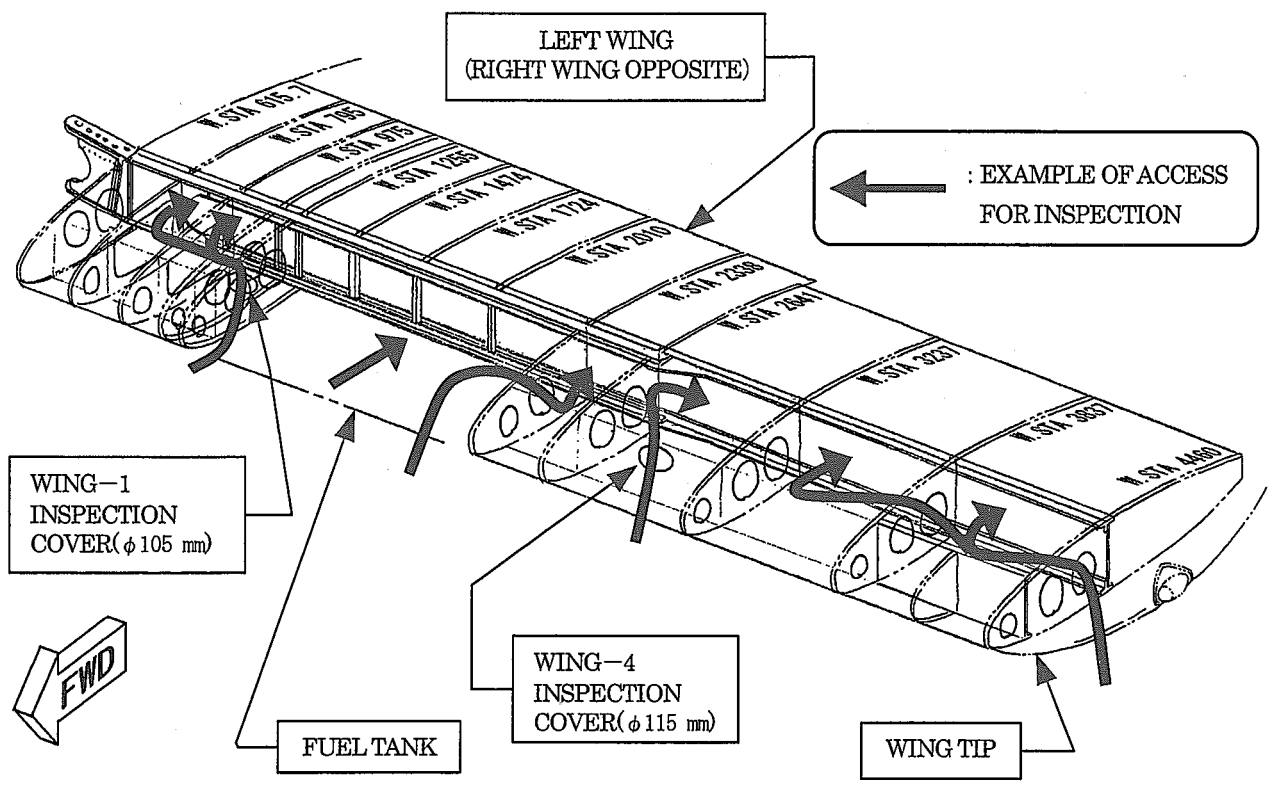
Figure-3 Inspection for Corrosion

(1) Inspect upper and lower flanges of main spar for corrosion, using an inspection mirror or other suitable tools through access opening for fuel system hoses (left and right wing – 1), access opening for Pitot tube and Pitot heater wiring (left wing – 4), access opening for stall limit switch wiring (right wing – 4) and lightening holes in each rib at W. STA 1255, 2338 (fuel tank bay) and W. STA 4460 (wing tip). (See Figure 3) At this time, also inspect main spar flanges at fuel tank bay for damages

or removal of paint flaking that may result in corrosion.

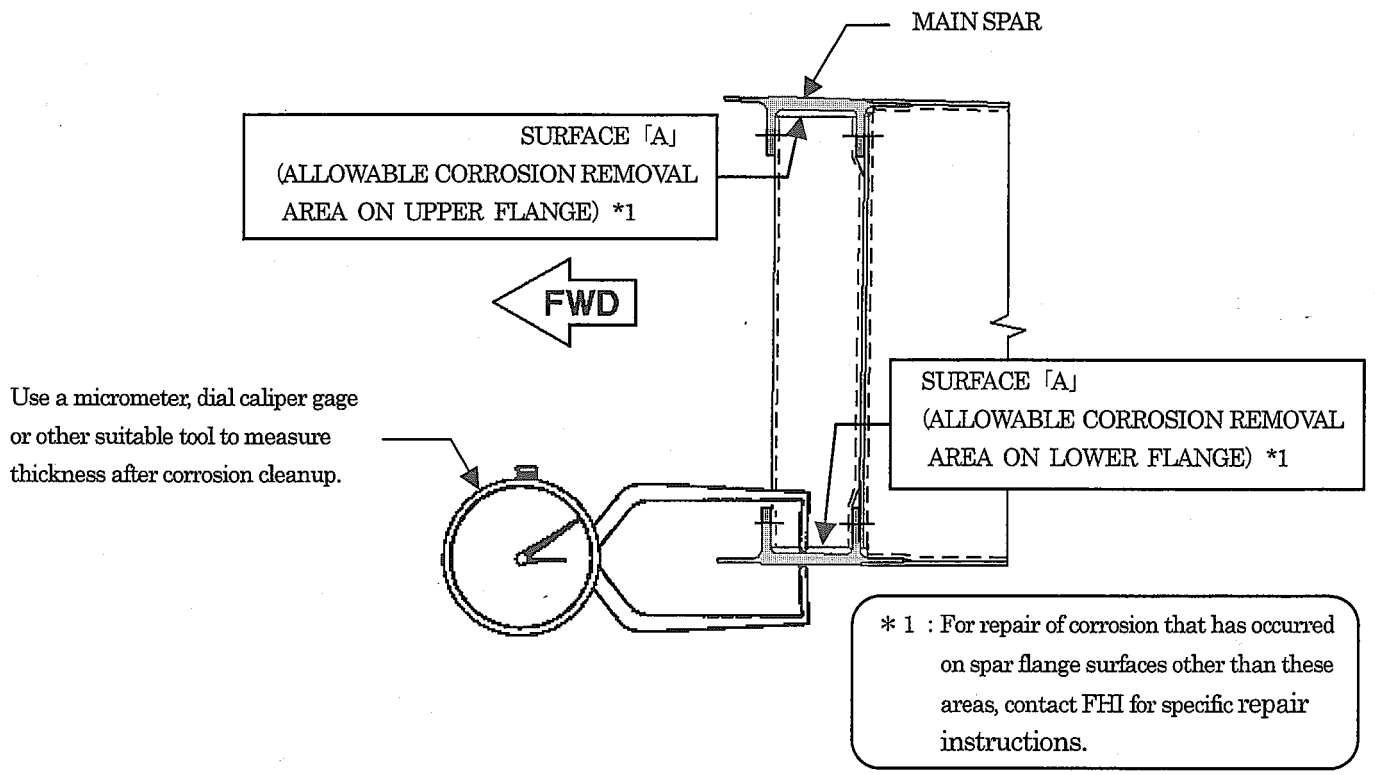
Figure-4 Measuring Method for Flange Thickness after Corrosion Clean-up

This paragraph provides repair procedure for corrosion that has occurred on the surface [A] (see Figure 4) of main spar flanges in fuel tank bay (located between W. STA 1255 and 2338). If corrosion is found on main spar flanges in areas other than fuel tank bay, contact FHI for specific corrosion removal instructions. Careless corrosion removal may adversely affect structural integrity of wings. Also, careless disassembly may result in failure of proper reassembly of aircraft.

- (1) Remove and blend corrosion, by sanding, on main spar flanges in fuel tank bay. Carefully inspect repaired area using a 10x magnifying, and polish out affected surface until corrosion has been completely eliminated. After corrosion removal, perform dye penetrant inspection or fluorescent penetrant inspection on the cleanup areas to ensure all corrosion has been removed.
- (2) Using a micrometer, dial caliper gage or other suitable tool, carefully measure the remaining thickness where corrosion has been removed. (see Figure 4) If the measured thickness exceeds minimum allowable limits (as specified in Figures 5 and 6), contact FHI for structural integrity evaluation.
- (3) Apply a coat of zinc chromate primer (MIL-P-8585 or equivalent) to the corrosion cleanup area.
