TECHNICAL BULLETIN FUJI HEAVY INDUSTRIES LTD.

NO. 200-022

: Installation of Improved Brake Link Rod for Rudder

2. AIRCRAFT AFFECTED: All FA-200 series aircraft S/N 12 through 297.

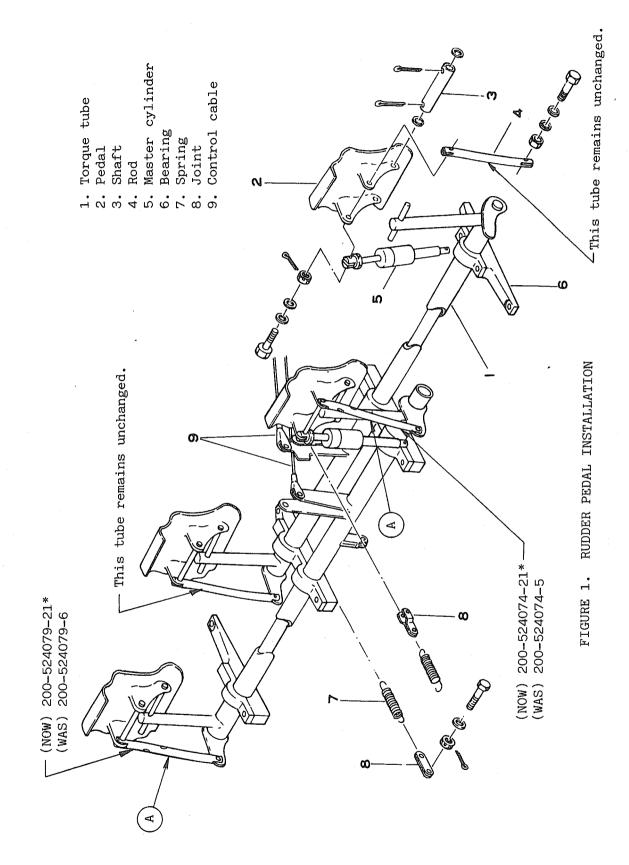
See figure 1.

: To increase safety margine for possible wear in

rudder pedal system.

*New tube is 5 mm longer than the existing tube.

- (1) Remove brake link rods P/N 200-524079-6 and 200-524075-5 (item A, figure 1) from each right pedal of left and right seats.
- (2) Install new rods P/N 200-524079-21 (for right seat) and 200-524074-21 (for left seat).

New rods must be installed as a matched set. Installation of either rod only is not permissible. New rod must be installed with "deeper slot in lower fork end" aft. This ensures adequate clearance between slotted rod end and mating part.

- (3) After installation of new rods, accomplish inspection in accordance with Service Bulletin 200-002C.
- (4) Service brake cylinders in accordance with the applicable service manual.
- (5) Check brake and rudder for proper operation.
- (6) Secure rod attaching nut with cotter pin P/N MS24665-134 (4 places).
- (7) Return airplane to flight status.
- (8) After rods have been replaced, make entry in aircraft log book.
