SERVICE BULLETIN

FUJI HEAVY INDUSTRIES LTD.

NO. 200-002

1. SUBJECT : Inspection and modification of rudder pedal operation.
2. AIRCRAFT AFFECTED : All FA-200 series aircraft S/N 12 thru. 297.
3. PRIORITY : Mandatory
4. REASON : To prevent overtravel of rudder pedal and to ensure proper operation of rudder control system, this bulletin specifies inspection and modification if required.
5. DESCRIPTION : (1) Inspection - Rudder Pedal Stop

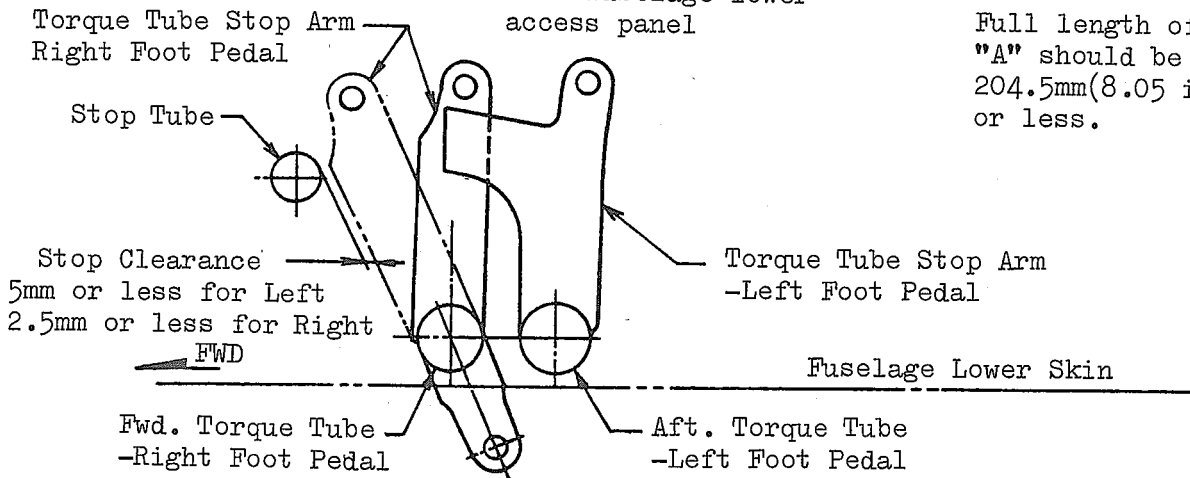
Fig. 2. STOP TUBE MODIFICATION

- (5) Remove stop tube and install collar assy as shown in Fig. 2, if the measured stop clearance still exceeds 5 mm (0.2 in) for left and 2.5 mm (0.1 in) for right after step (4) is performed.
Removal of stop tube can be accomplished by removing either one of cotter pins.

Make thru hole ($\frac{.128}{.125}$ in) as shown in Fig. 2 and apply zinc chromate primer or equivalent corrosion preventive paint to the holes.
